EPAL 7 half pallet 800 x 600 mm

Facts & figures

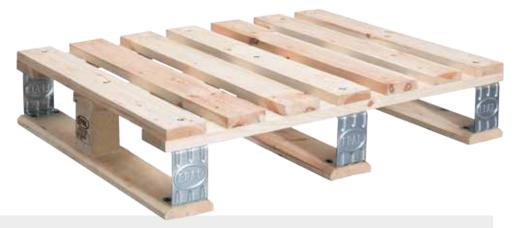
Materials: 13 boards of quality timber, 3 woodchip or solid wood blocks, 48 nails, 6 sturdy 3-mm steel angle brackets, 21 tubular rivets. Produced according to the EPAL Technical Regulations.

Length	800 mm
Width	600 mm
Height	160 mm
Weight	Approx. 9.5 kg
Safe working load	500 kg

When stacking laden pallets on a solid, even surface, the bottommost pallet must not exceed a load of max. 2,000 kg.

4-sided accessibility with chamfered lower edge boards on both sides enables highly efficient handling during production, storage and transportation all the way along the supply chain. Compatible with all (conventional) standard load carriers, industrial trucks and warehouse systems.
